Residential Inspection Report

Property Address:
Sample Property

US Building Inspectors, Inc.

This inspection report is for a I-level Single Family Home built in 1989. The contents in this report are going to reflect the condition of the home and its components in relation to a house built in 1989.

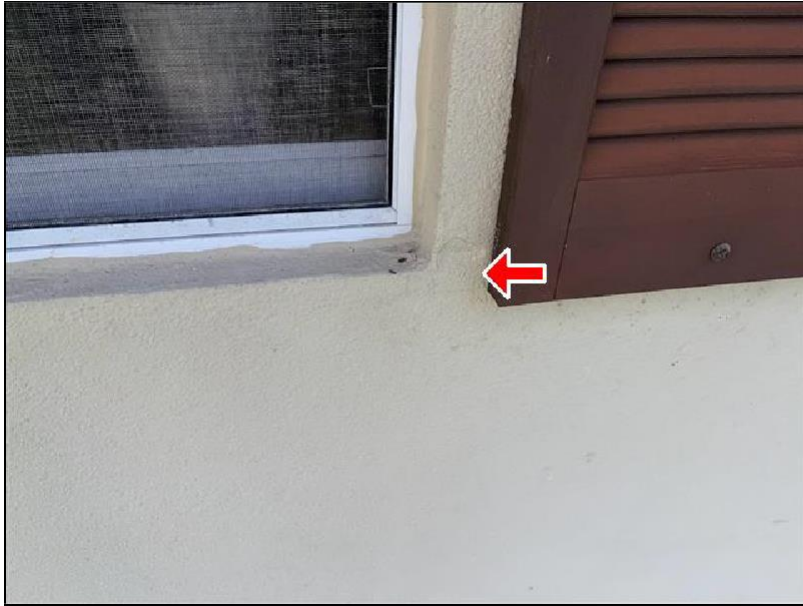
3.3 Item 1 (Picture)

Exterior window sills may have some cracks present.

Windows outside of this home have or may have an older window seal that can crack and deteriorate when exposed to the hottest sunlight during certain parts of the day. Water can perk through concrete block and affect the inside of the house. When homes are built, the outside of the home is waterproofed/sealed, but over time, and hot sun, this waterproofing can and will deteriorate.

The hot Florida sun tends to heat up and deteriorate the original window seals on the exterior of the home and need to be re-sealed every 4-5 years, depending on variables.

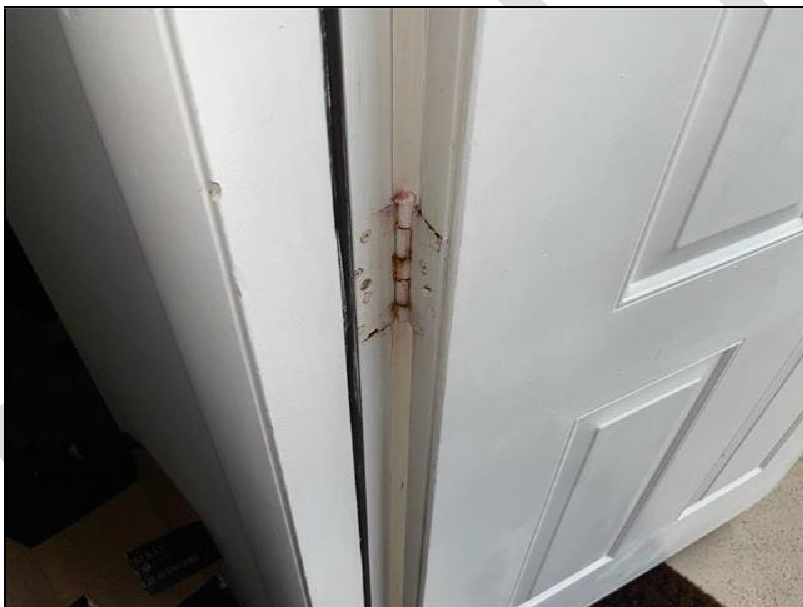
3.4 Item 1 (Picture)

The front door is very hard to open/close. Corroded hinges observed. Recommend further evaluation by a licensed contractor for repairs.

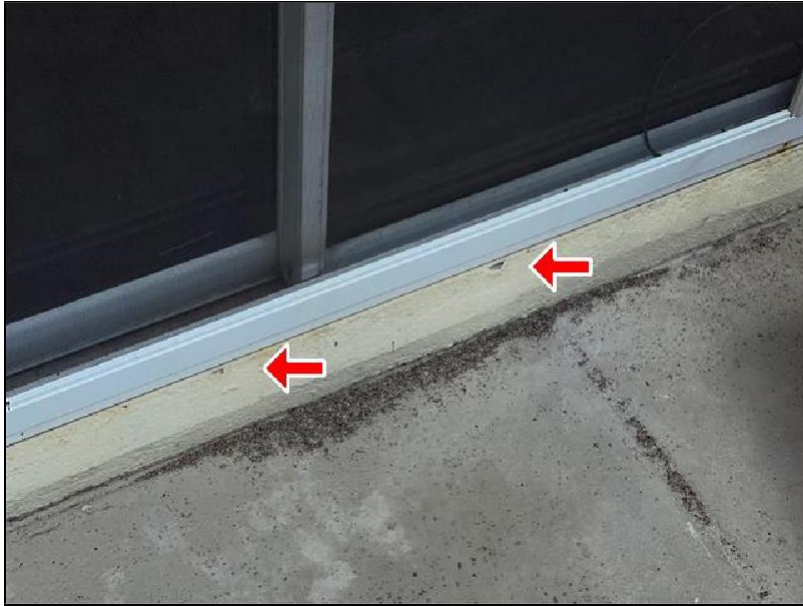
3.4 Item 2(Picture)

Sliding glass doors are functional but the wheels at the base of them are in need of being cleaned and lubricated. Vacuum the track and continue to open and close the sliding glass doors repeatedly so they will continue to drop more and more debris from the wheels. Then once they are clean you can lubricate the wheels with a special lubricant (not WD-40) for this particular use. Use a lubricant specially made for lubricating sliding glass door wheels, like DuPont Teflon Non-Stick Dry-Film Lubricant Aerosol Spray, or something similar. WD-40 is useful for other projects. If this does not work, recommend further evaluation by a licensed window and door company for replacement of the rollers.

Recommend re-sealing the base of the sliding glass doors to prevent water damage.

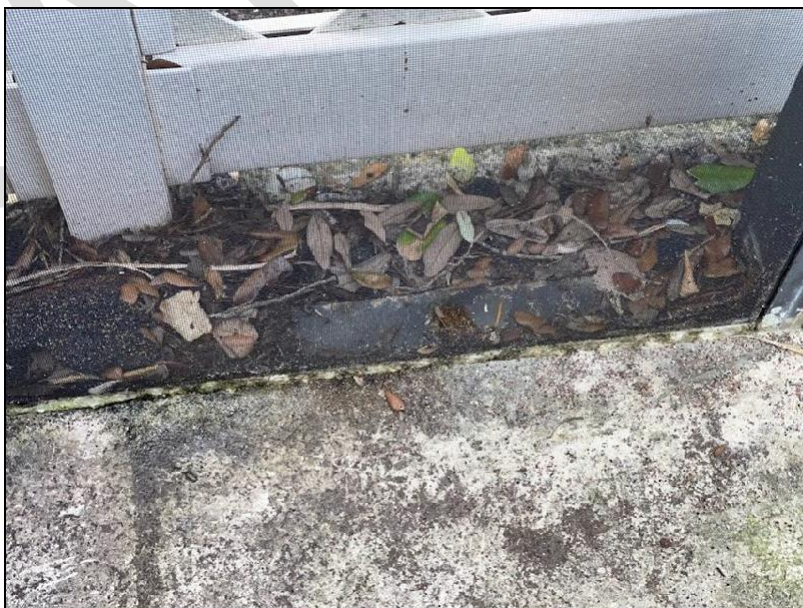
3.6 Item 1(Picture)

Ripped screens and corroded framing observed to the screen enclosure.

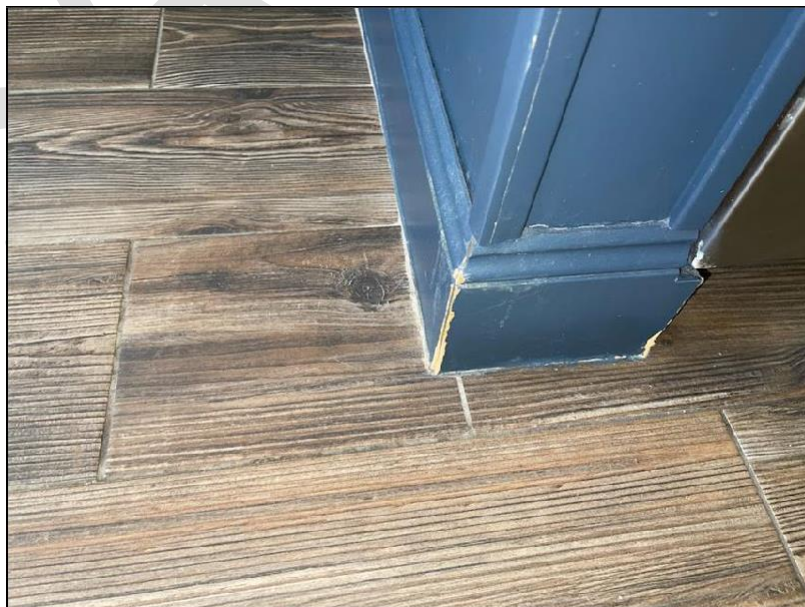
5.0 Item 1(Picture)

Water staining observed from previous leak, to the base under the sink and around the dishwasher. Recommend removal and replacement of all damaged materials, by a licensed contractor.

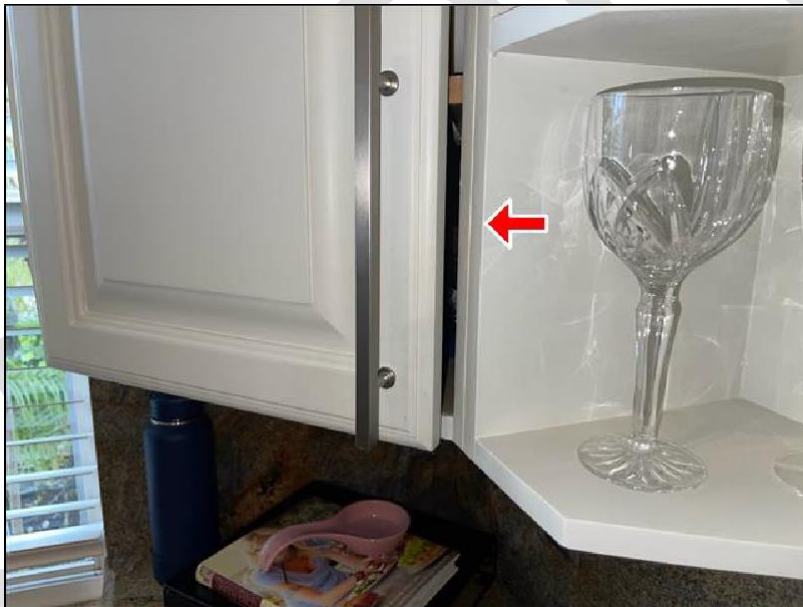
5.0 Item 3(Picture)

The cabinet door to the right of the kitchen window does not properly fit and is loose.

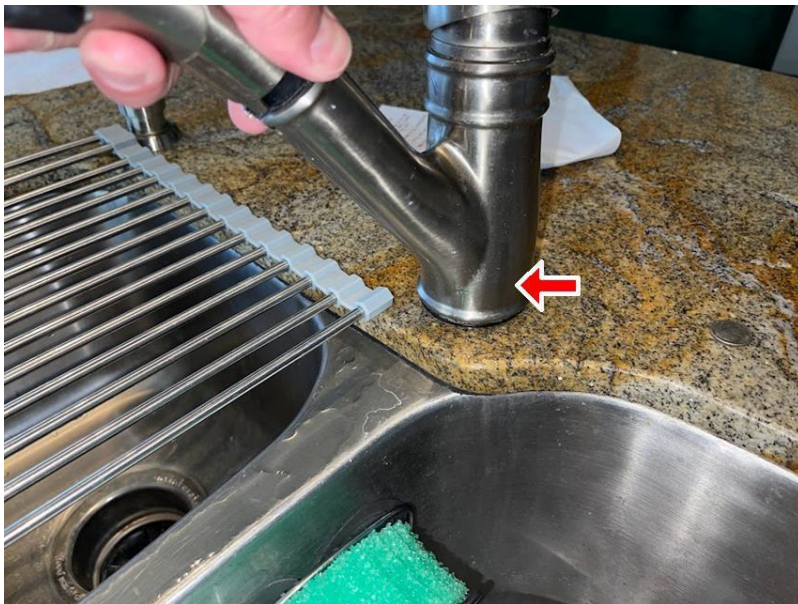
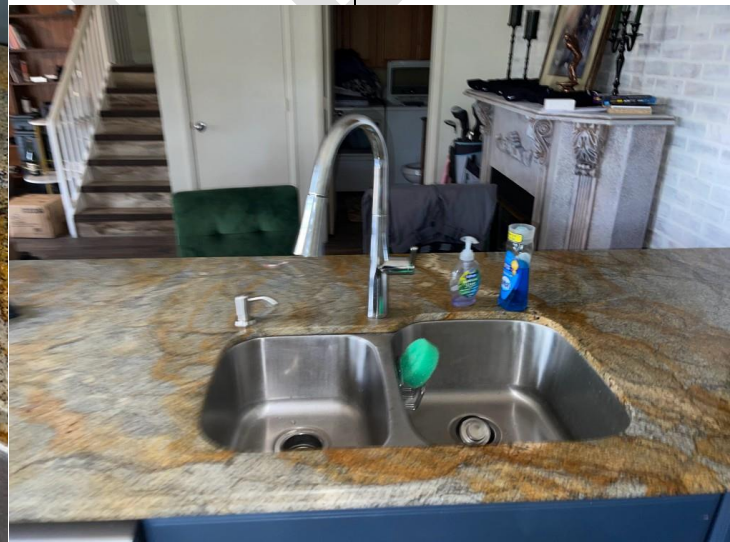
6.0 Item 1 (Picture)

new sink faucet installed - re-inspection performed 6/14/2023

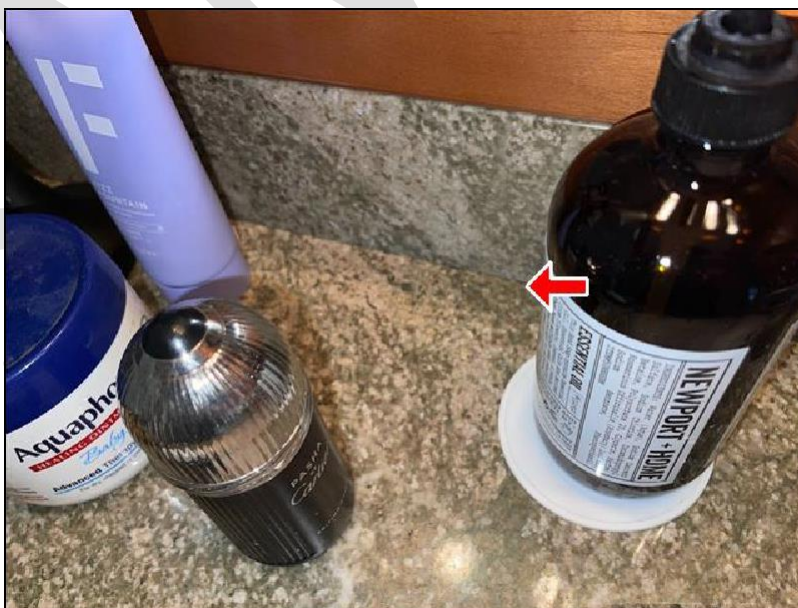
7.1 Item I(Picture)

Guest bathroom has a granite countertop and sink. It is in good condition. Composite vanity sink cabinet. **Recommend re-sealing the backsplash to prevent water damage below.**

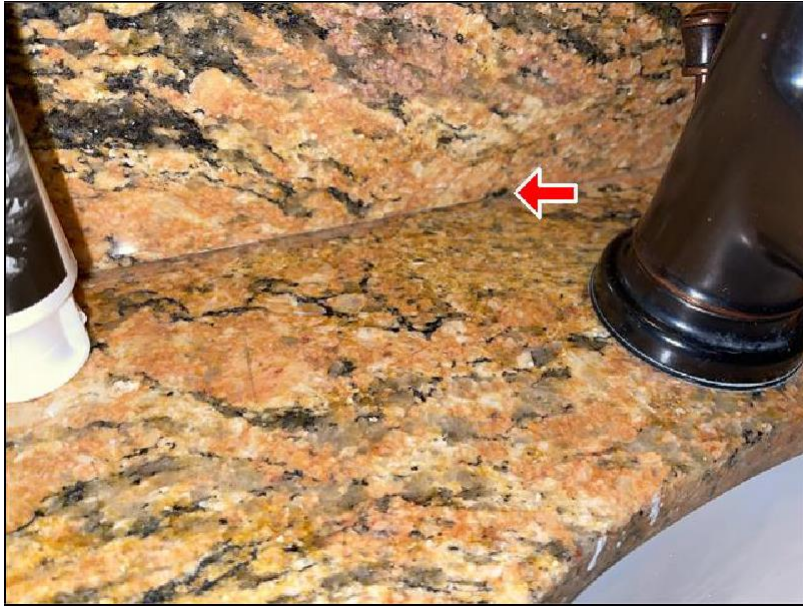
7.1 Item 2(Picture)

Master bathroom has a granite countertop and sink. It is in good condition. Composite vanity sink cabinet. **Recommend re-sealing the backsplash to prevent water damage below.**

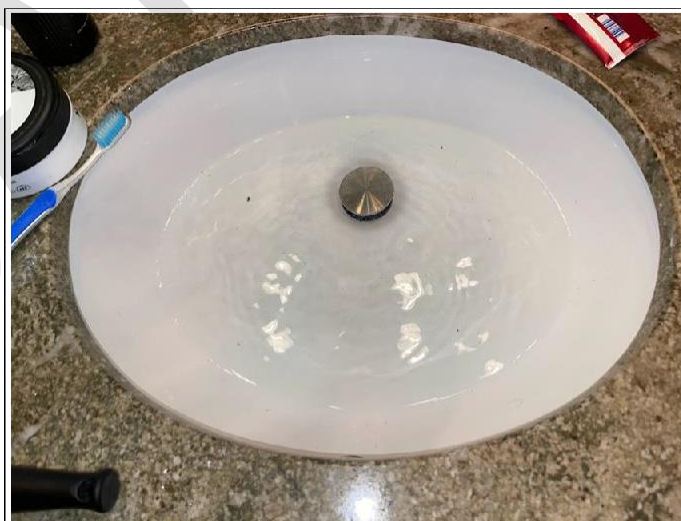
7.2 Item 1 (Picture)

Master bathroom sink shown. Hot and cold water working fine. Drain lines working fine. Copper plumbing distribution lines. Braided supply lines. PVC drainline. Active leak observed at the drain. Recommend repairs by a licensed plumber.

Re-Inspection on 6/14/2023 - the master bathroom sink valve was replaced.

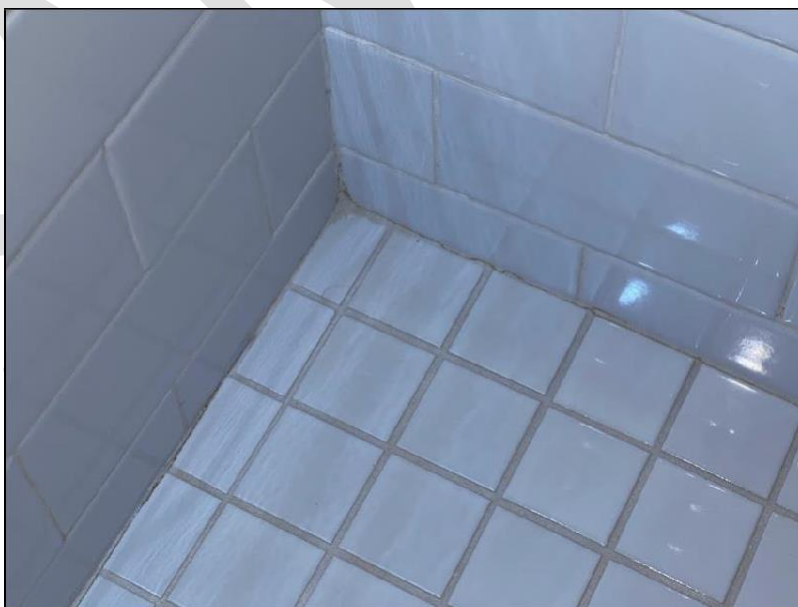
7.3 Item 1(Picture)

Shower enclosure appears to be in good working order in the Master bathroom. **Recommend re-sealing the shower enclosure to prevent water damage and replacement of the bottom seal to the door.**

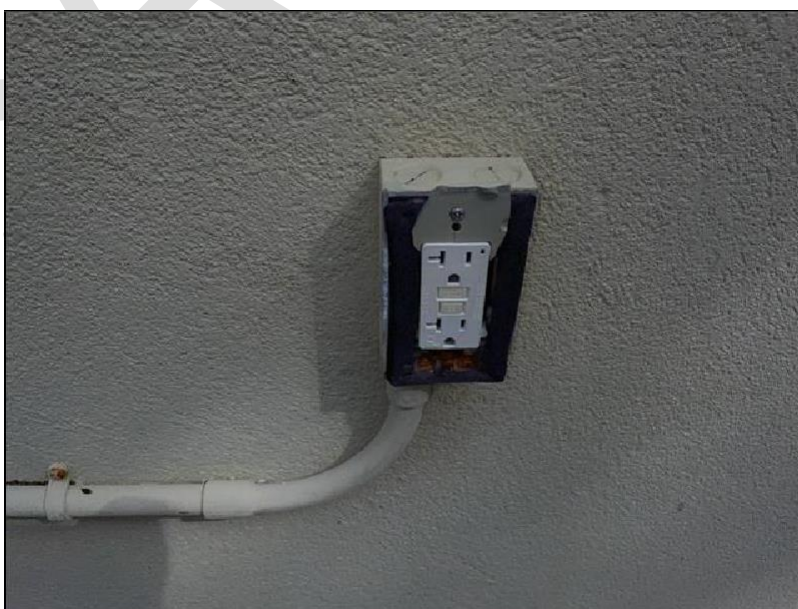
8.2 Item 1 (Picture)

8.2 Missing exterior weather receptacle cover. Recommend replacement by a licensed electrician.

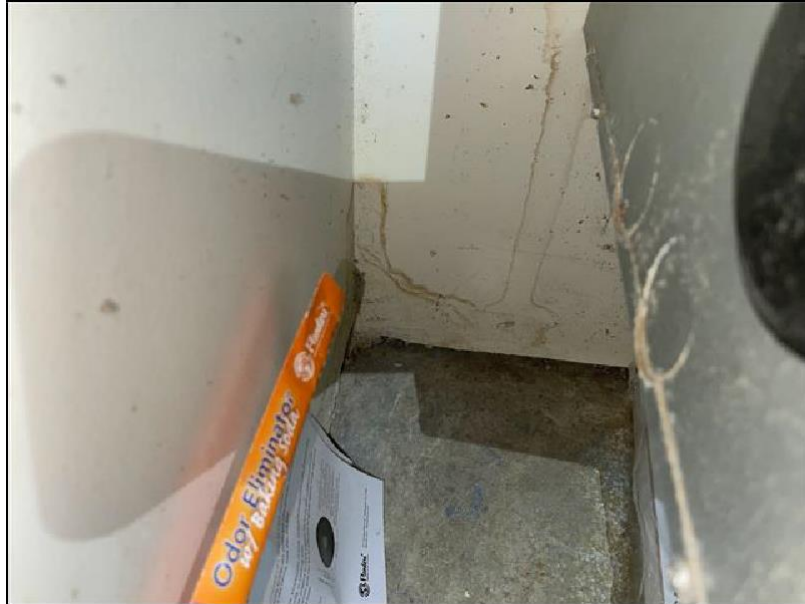
11.0 Item 1 (Picture)

Budget for future replacement. The word "future" could mean the as soon as you take ownership, or months down the road, or in years to come. I cannot predict exactly when an air conditioning will fail, but they typically have a life span of 10-15 years +/- depending on how well they are maintained, and of course they can last longer, but this air conditioning system is 10 years of age.

Recommending having this system serviced prior to moving in by a licensed and insured HVAC company.

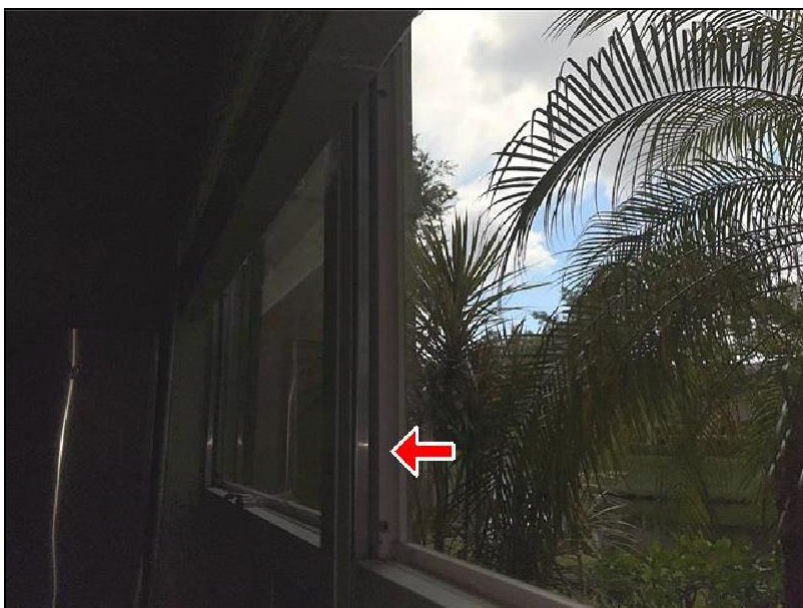
12.4 Item 1 (Picture)

A representative number of windows in areas of the home, bedrooms, bathrooms, were tested for functionality. Some window screens may have been missing. Recommend any screens missing are replaced. I do not recall any of them being missing though.
