Commercial Building Inspection Report

Property Address: sample

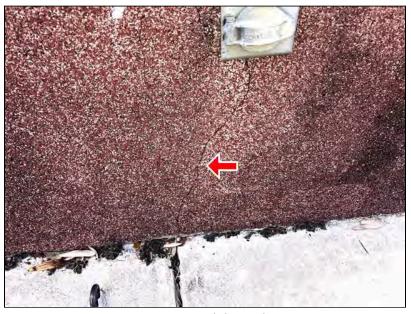
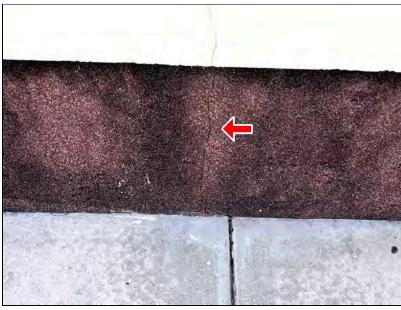
Damaged concrete at exterior walls on all sides of the building, which could result to leaks to the foundation which could eventually cause a mold issue, which could be especially problematic for someone whom is allergic or hypersensitive to mold. Recommend further evaluation by a licensed and insured general contractor whom specializes in foundation and structure, and/or a licensed and insured structural engineer. This should be done while still in your due diligence period.

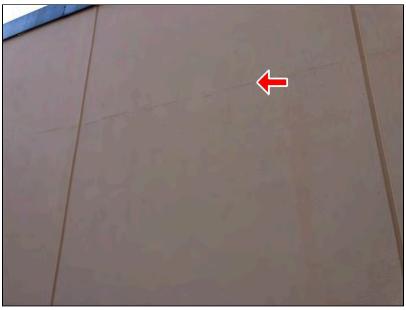
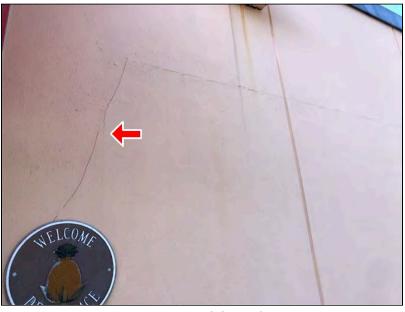
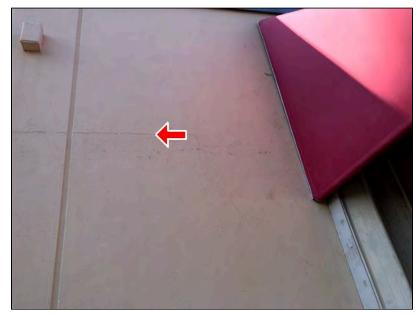
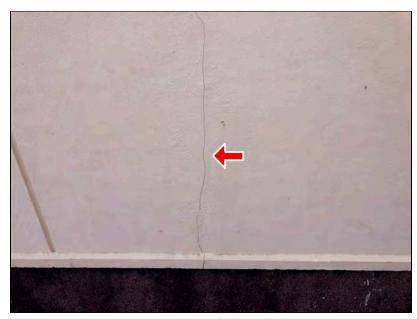
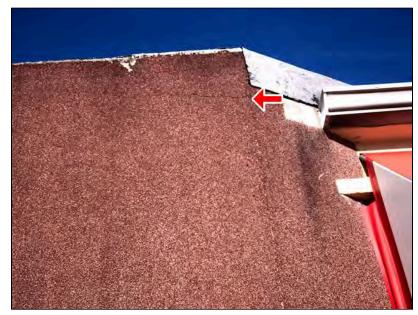
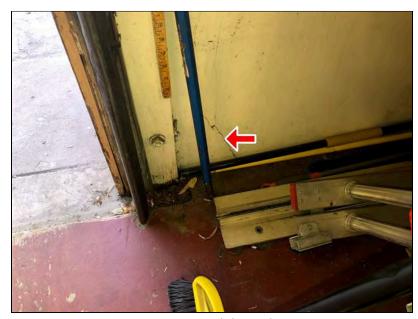
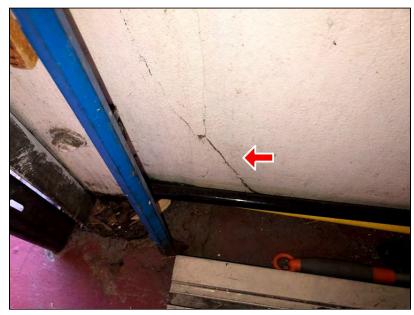
Cracking observed to the walls around the structure. Recommend further evaluation by a licensed contractor for proper re-sealing of these areas, to prevent water intrusion and damage.

Peeling and balding pebble finish observed to the base of the walls and along the street. Recommend further evaluation by a licensed contractor for repairs.

Further cracking was observed around the garage door at the interior and exterior. Recommend further evaluation by a licensed contractor for repairs.

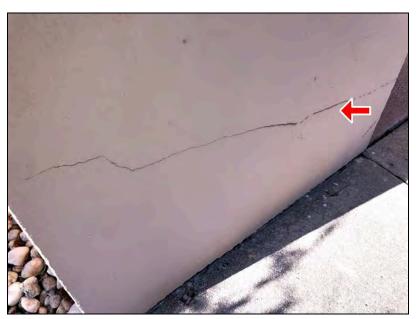
3.4 Item 1(Picture)

Cracking and deflection observed to the front left columns. This area may need to be chipped out and repair, by a licensed contractor, to prevent further cracking and damage.

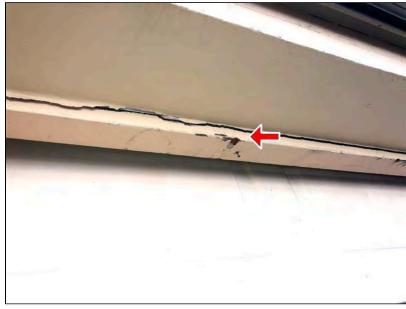
3.5 Item 1(Picture)

Separation and water damage was observed around the garage door to the trim. Recommend removal and replacement of all damaged materials.

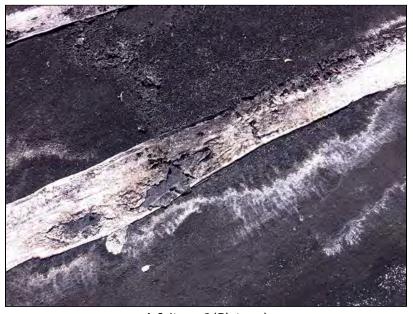
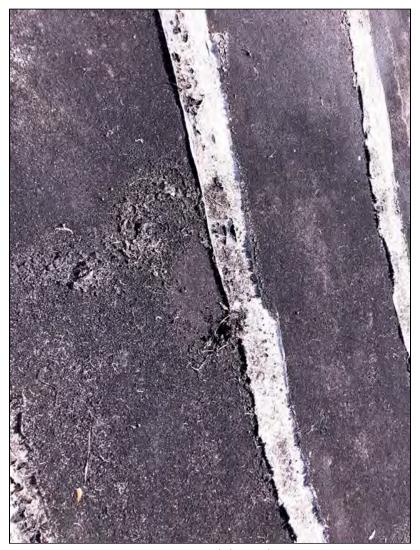
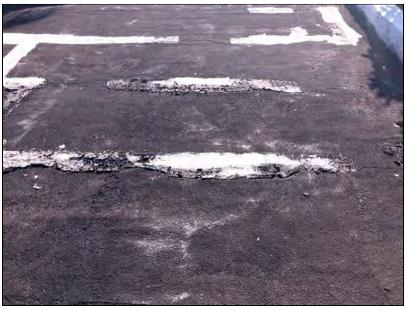
Modified bitumen roof, with balding, bubbling and poorly done patches observed. Roof is in poor to fair condition for its age. Budget for eventual replacement. The roof may have 1-2 year life expectancy, more or less, depending on variables, beyond our control to give a guesstimate of time remaining. Lightening strikes, storm damage, can change this prediction in an instant.

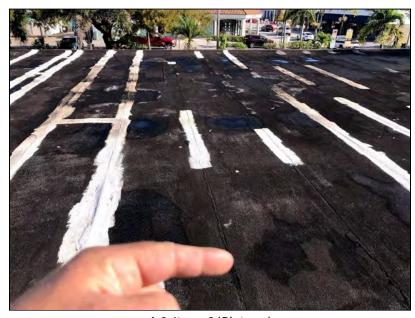
4.1 Item 1(Picture)

Loose roof decking observed along the left side of the building halfway towards the center.

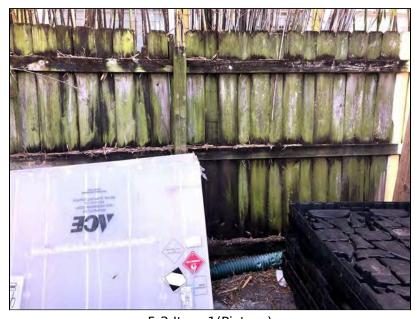
5.3 Item 1(Picture)

Rotted fencing observed along the left and rear side of the building.

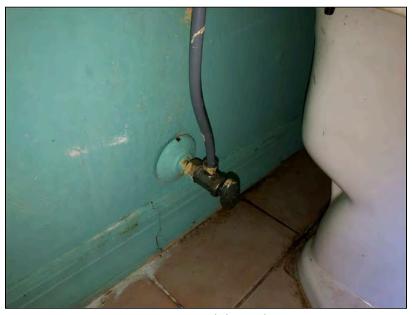
6.0 Item 1(Picture)

His bathroom toilet shown is in good condition. Functions properly, is affixed to floor properly, is not leaking.

Hers bathroom toilet shown is in good condition. Functions properly, is affixed to floor properly, is not leaking. Recommend replacement of the polybutylene supply line to the toilet, by a licensed plumber.

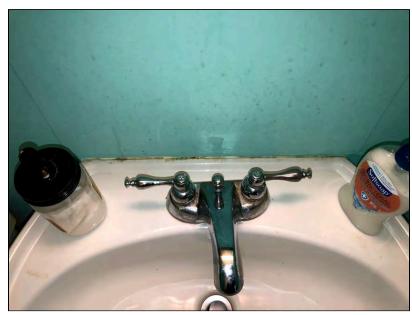
6.1 Item 1(Picture)

Open caulk seal present at the backsplash. Recommend re-caulking where necessary.

His bathroom has a pedestal sink. It is in good condition. Recommend re-sealing the pedestal sink to the wall.

Hers bathroom has a pedestal sink. It is in good condition.

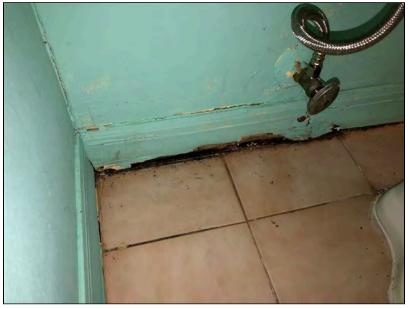
6.4 Item 1(Picture)

The base of the wall, between the bathrooms is completely rotted away. Recommend further

evaluation by a licensed contractor for removal and replacement of all damaged materials. Remember that once removal has begun, additional damage may be found inside the wall that is not visible at the time of inspection.

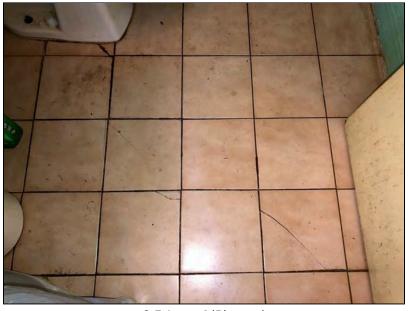
6.5 Item 1(Picture)

Damaged and cracked tiles observed in the hers bathroom at the door and around the toilet.

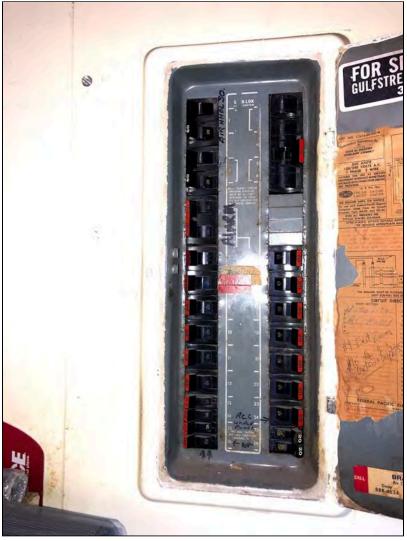
7.0 Item 1(Picture)

Breaker panel is an FPE / Stab Lok brand panel. FPE / Stab Lok panels are no longer manufactured in the U.S. due to flaws in the design and the possibility that circuit breakers may malfunction. Recommend invasive evaluation and request for a quote to replace the FPE panel by a licensed electrician. Most, if not all, insurance companies will not insure a building with an FPE panel. This panel needs to be replaced. Even if the current owner has the building insured does not mean an insurance carrier will insure the building for you when you take ownership of it.

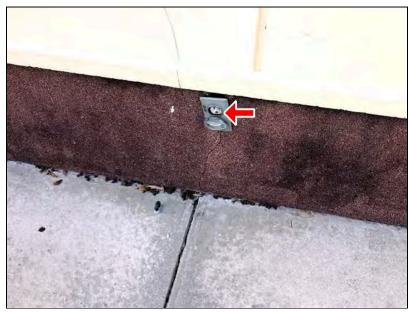
7.3 Item 1(Picture)

Garage receptacles are not GFCI-protected. Protect yourself and your employees, and any trade professionals from being shocked or electrocuted by having GFCI-receptacles installed immediately, prior to taking occupancy, and prior to having anyone work in the building. It could save a life and a lawsuit. Both unnecessary if tragedy were to happen. Do not ignore or put off this recommendation!!

No GFCI's at the exterior of the structure. They should all be GFCI protected. In doing so, will prevent potential shock, electrocution or death.

Recommend replacement of the damaged weather receptacle covers.

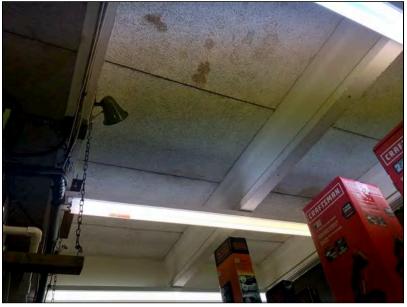
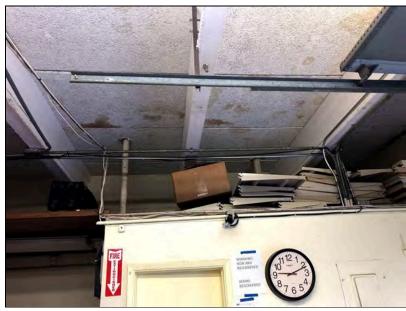
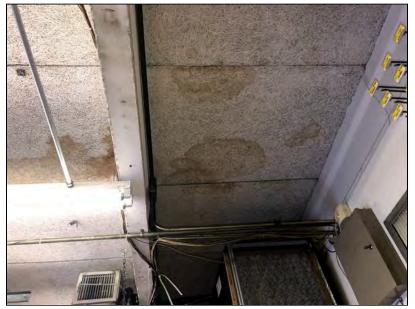
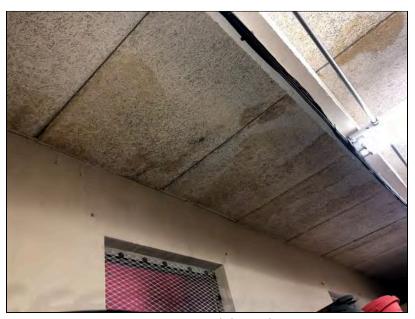
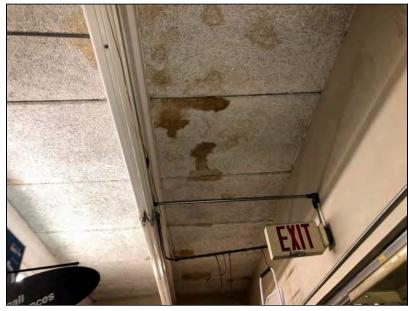
Water staining observed to most of the ceiling panels throughout the building, from previous and present roof leaks. Recommend further evaluation by a licensed roofer and contractor for repairs.

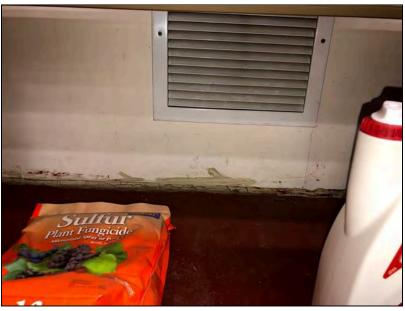
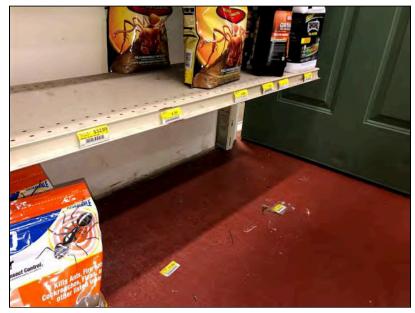
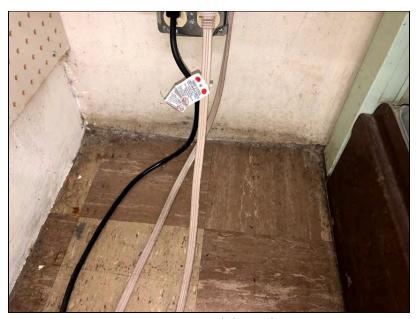
Water damage and poorly done seals and repairs observed to the base of the office door.

Evidence of water intrusion and cracking observed to the interior of the front wall, to the right of the front door. Recommend further evaluation by a licensed contractor for repairs.

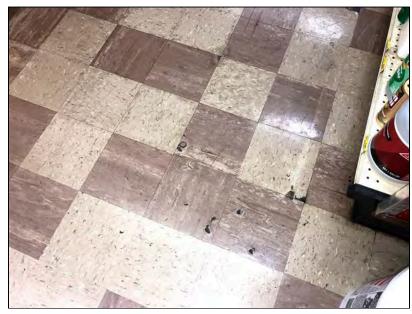
10.2 Item 1(Picture)

Damaged flooring observed throughout the building.
